**AGUA HEDIONDA
INTEGRATED WATERSHED MANAGEMENT PLAN:
STREAM RESTORATION OPPORTUNITIES**

APPENDIX A

OPPORTUNITY SITE PHOTOGRAPHS

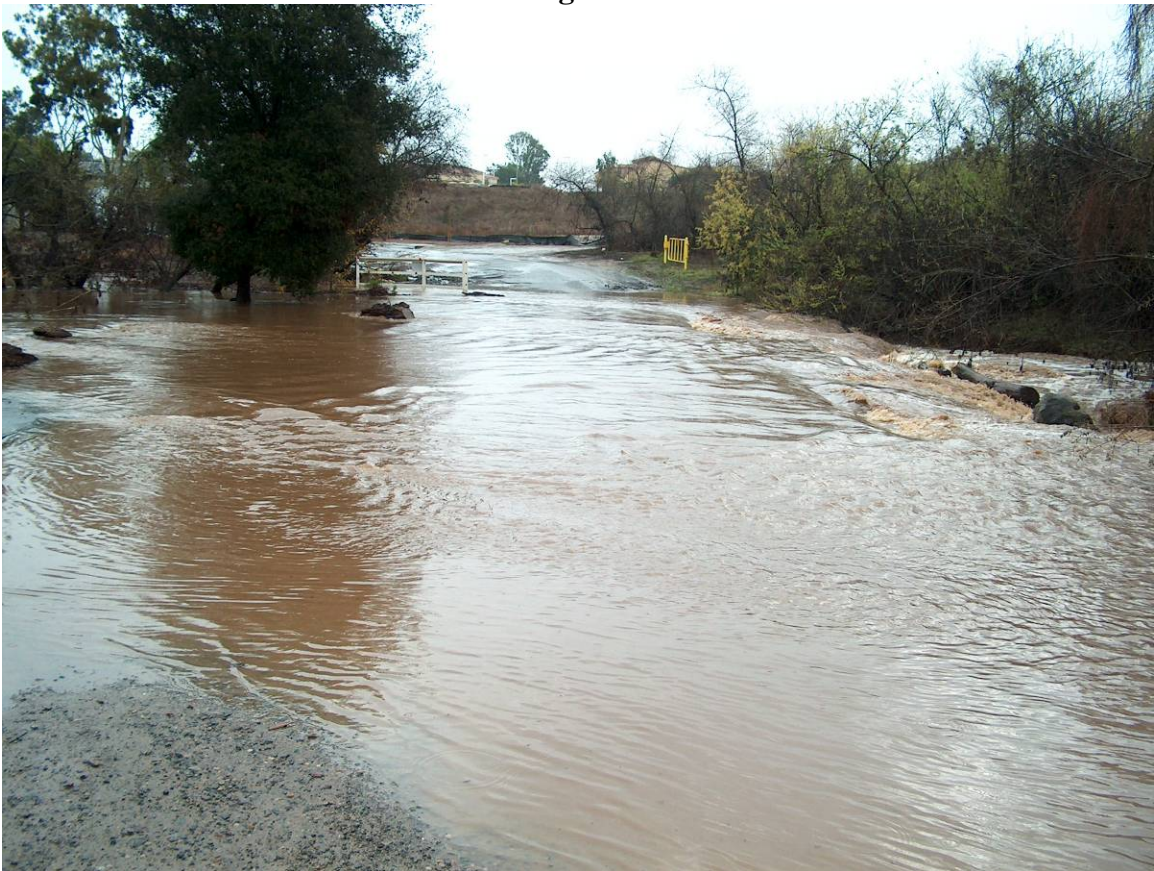
SR1-4 – Green Oak front entrance during 2004 storm event

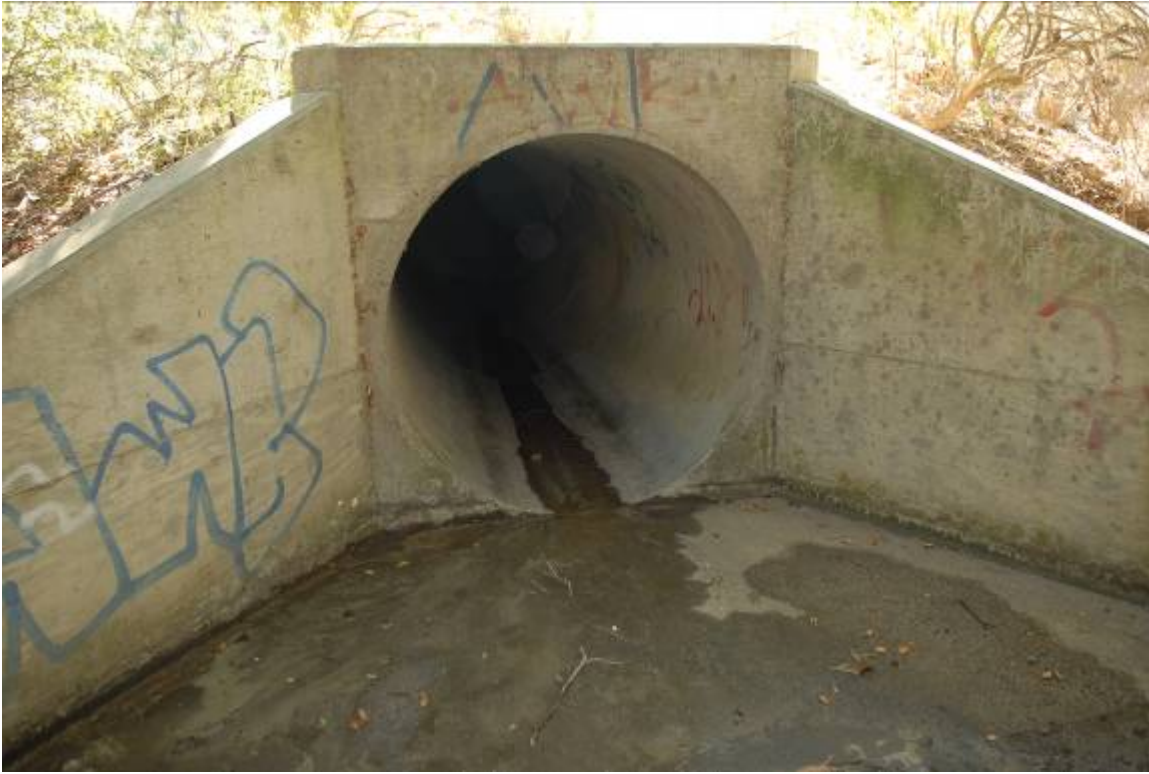
SR2-3a – culvert outfall in 2008

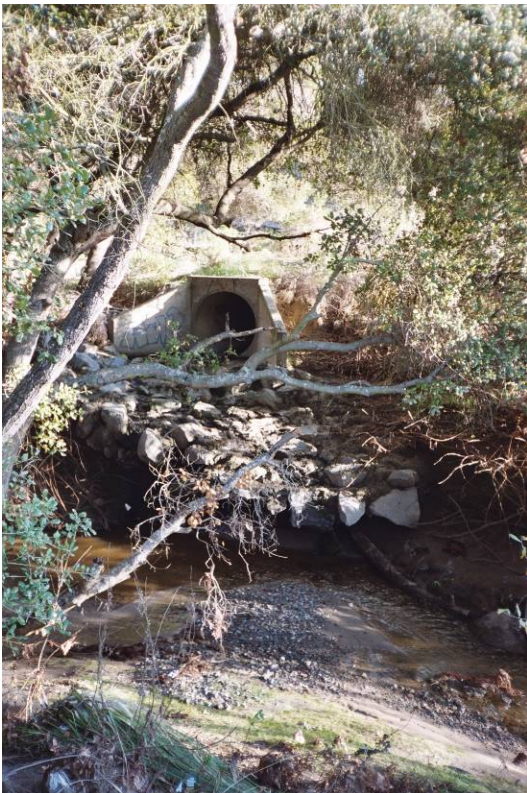
SR2-3b – culvert outfall in 2004

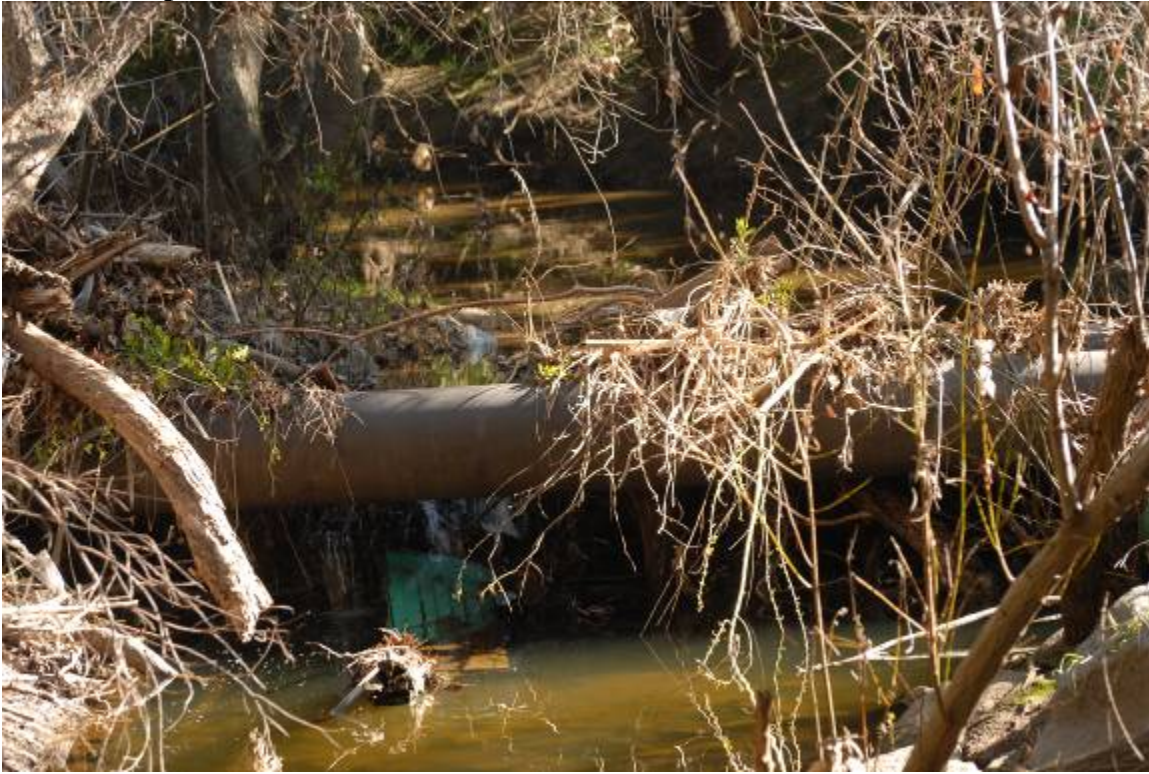
SR2-4a – exposed sewer line in 2008

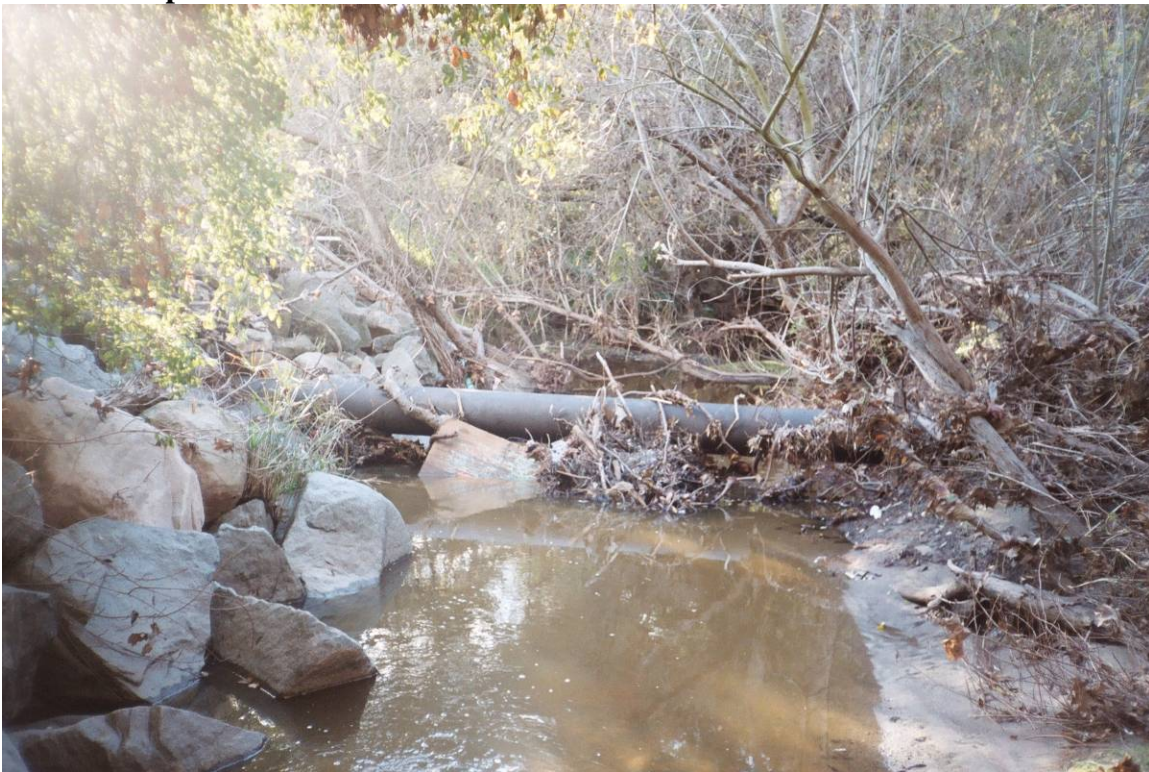
SR2-4b – exposed sewer line in 2005

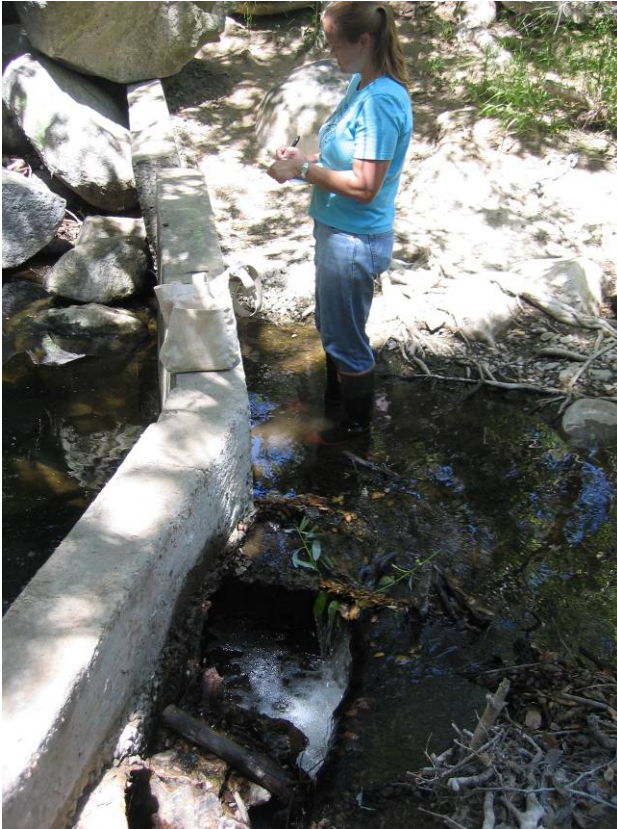
SR2-6b – three months later

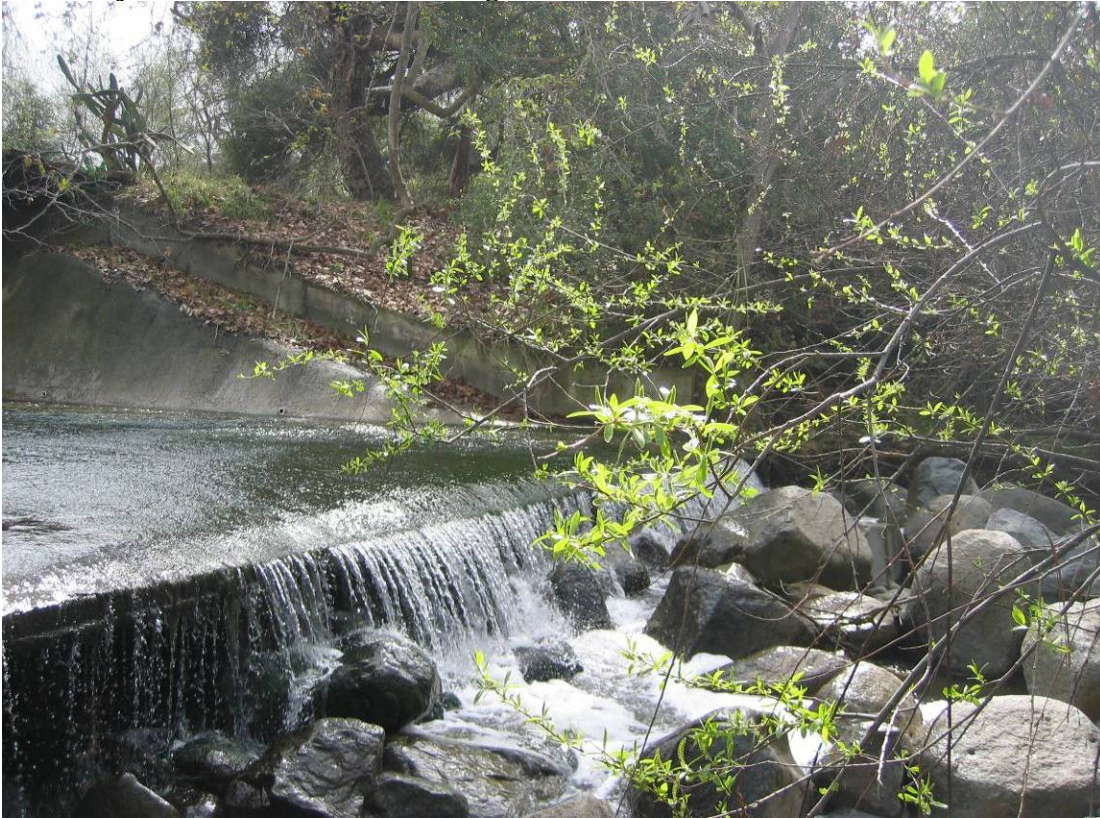
SR5-2 – just downstream of crossing onto Oak Lake Ranch.

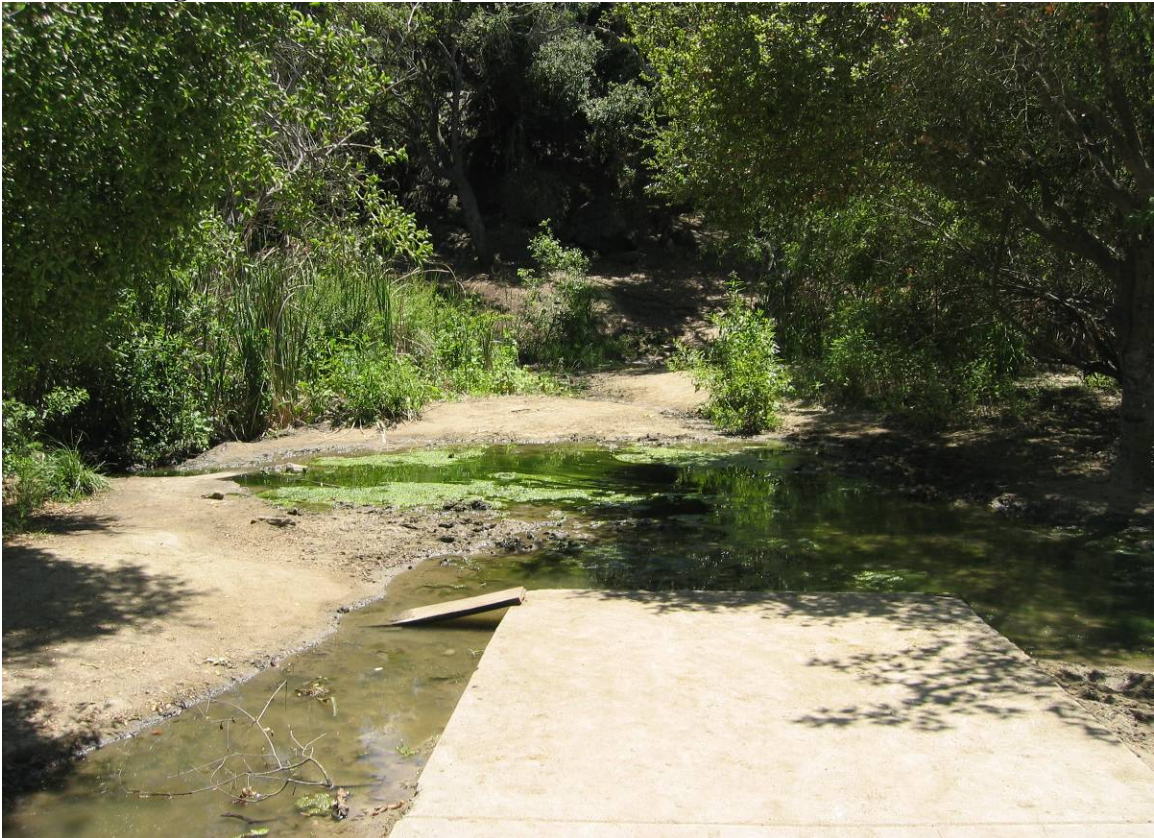
SR9-1a – stagnant water, Oak Riparian Park

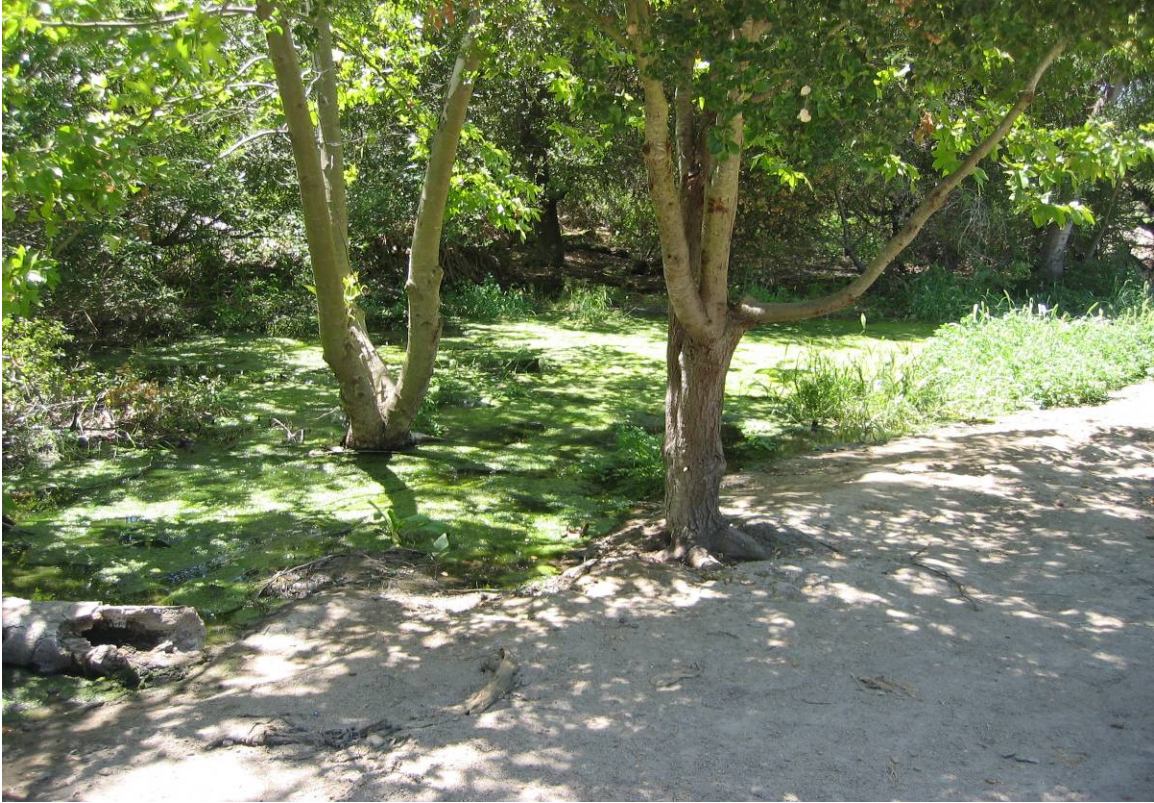
SR9-1b – stagnant water with algae, Oak Riparian Park

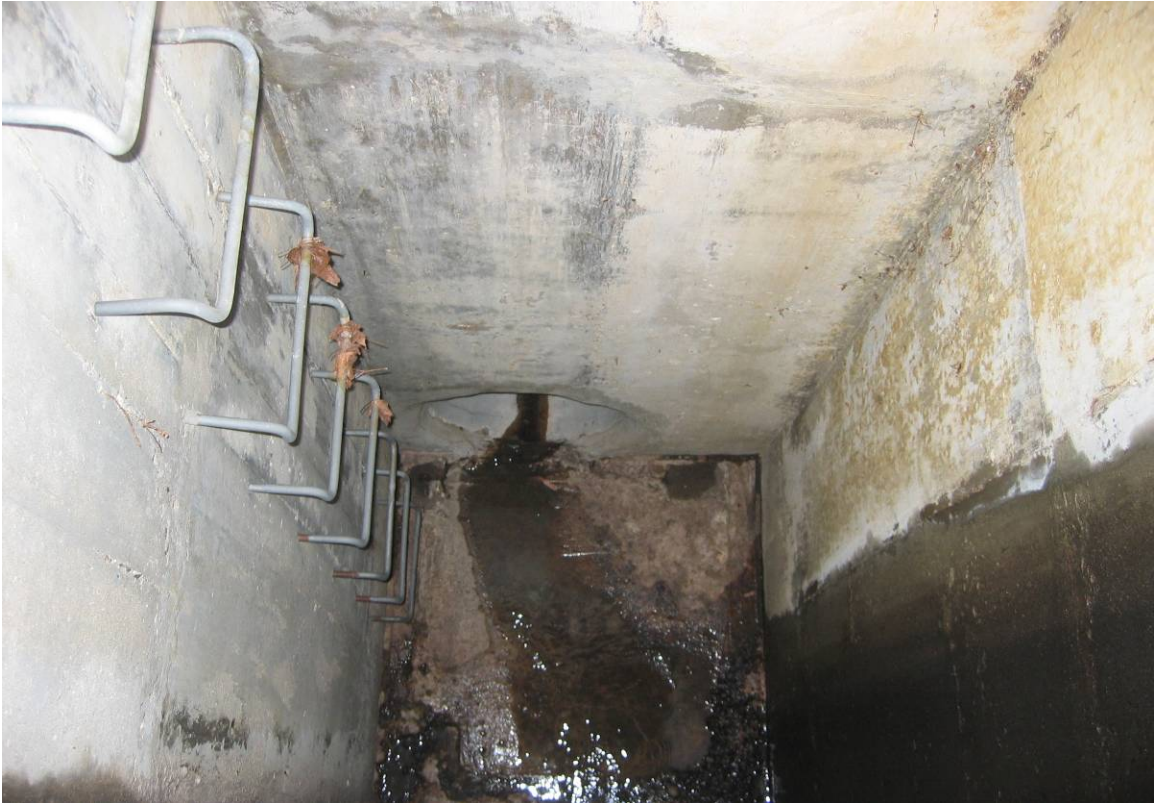
SW2-1 – storm drain

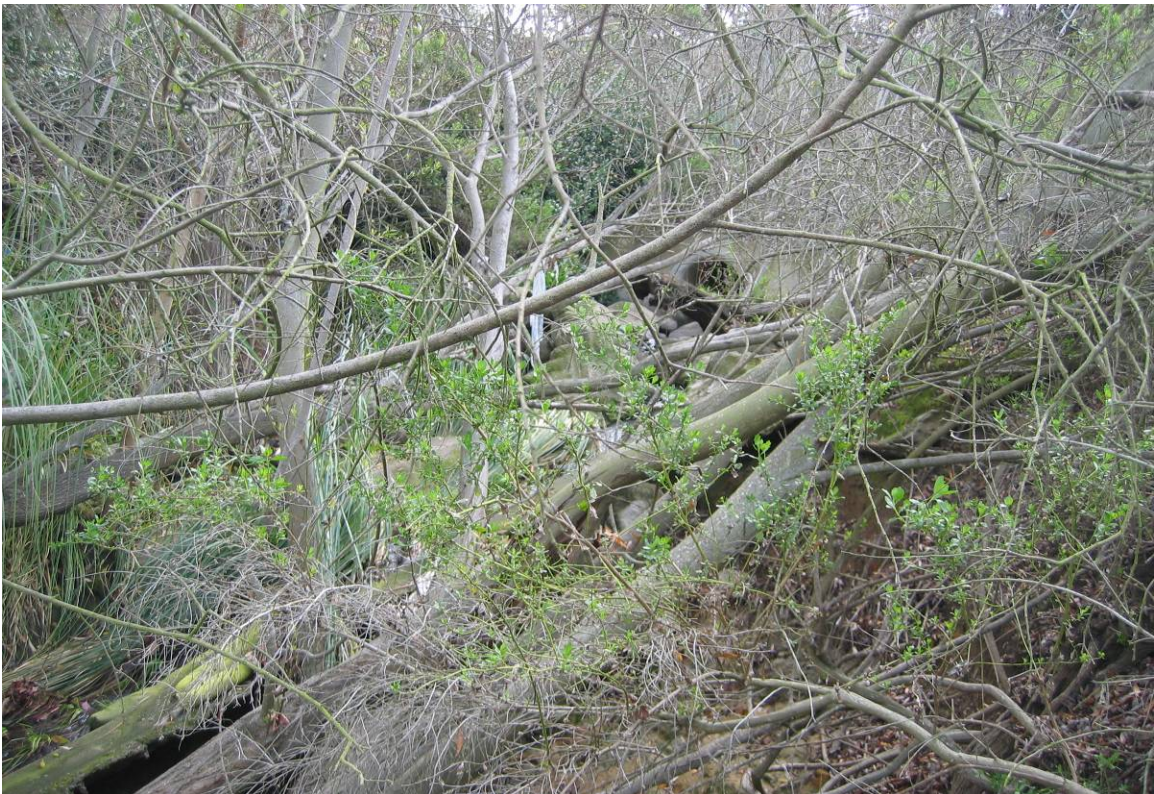
SW2-2 – storm drain outlet

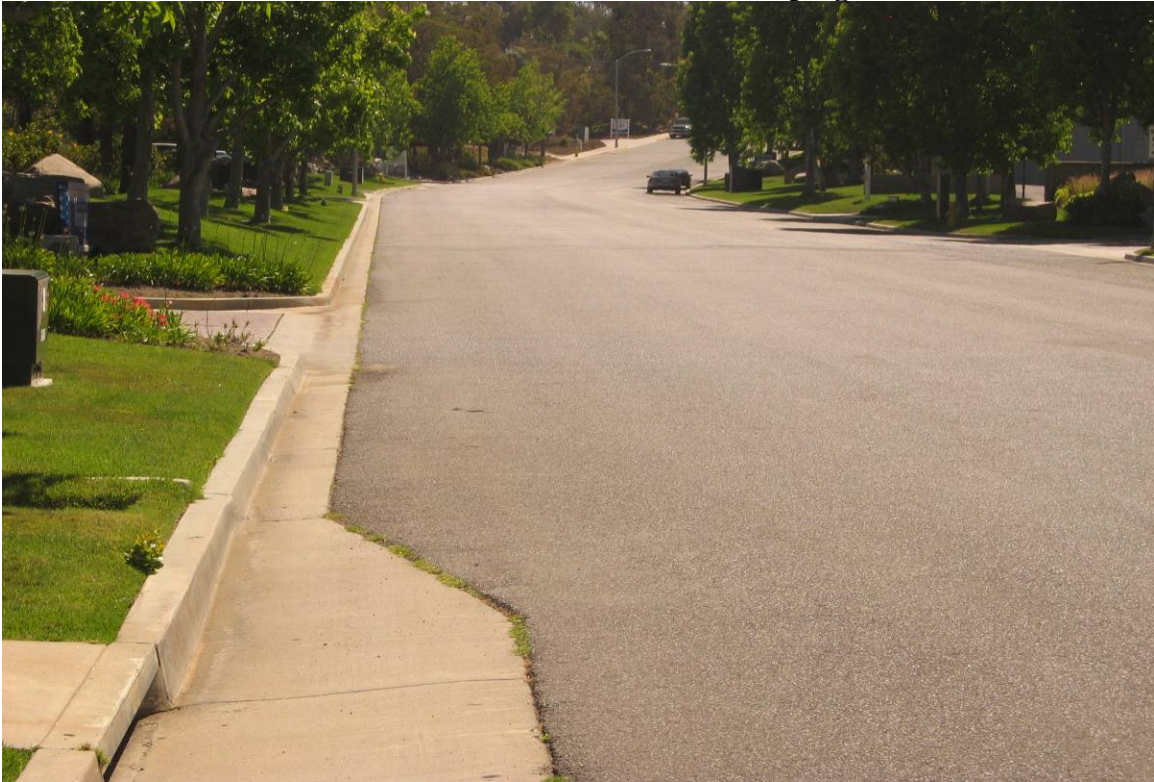
SW2-3 – storm drain catch basin and commercial landscaping

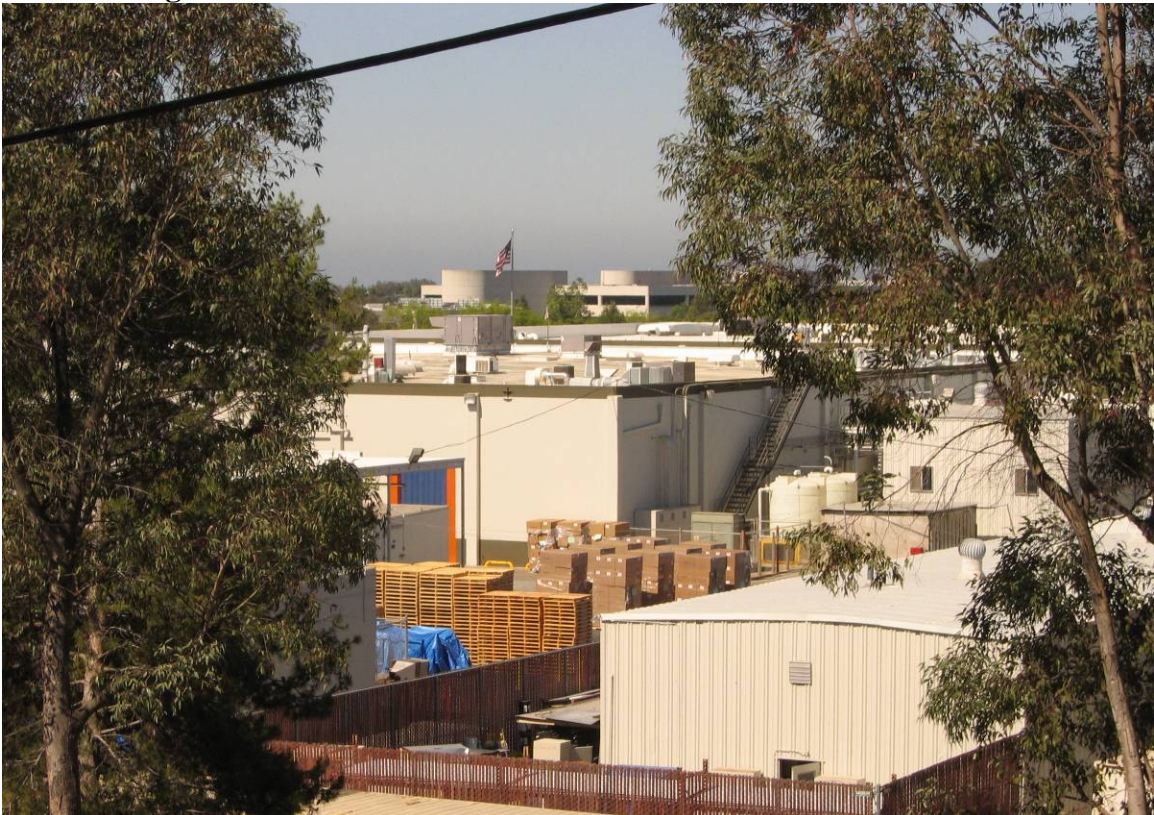
SW2-4 – large commercial roof surface area

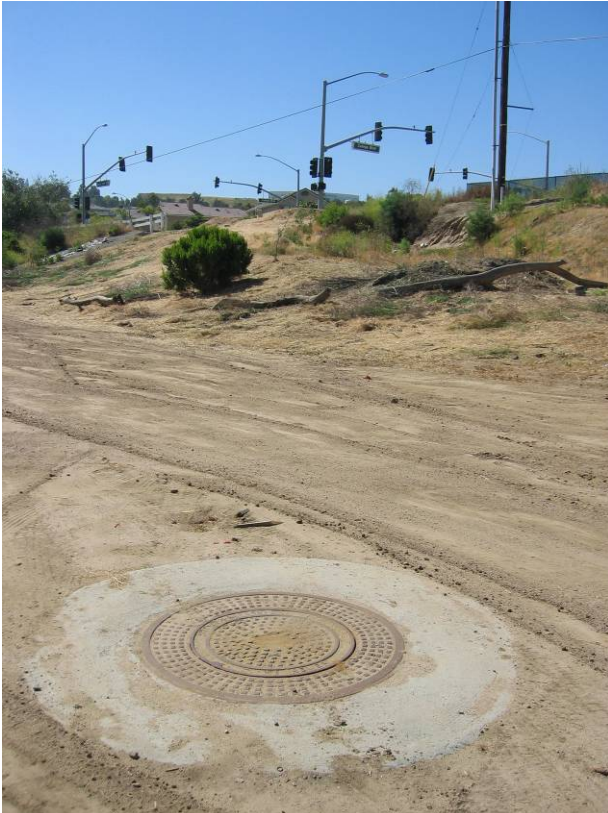
SW4-2 – stormwater access below end of College Road
