Appendix D. Additional Data Collection and Design for SR-02

Agua Hedionda Watershed Restoration Opportunity Site: SR-2

**City of Vista
California**

August 2008

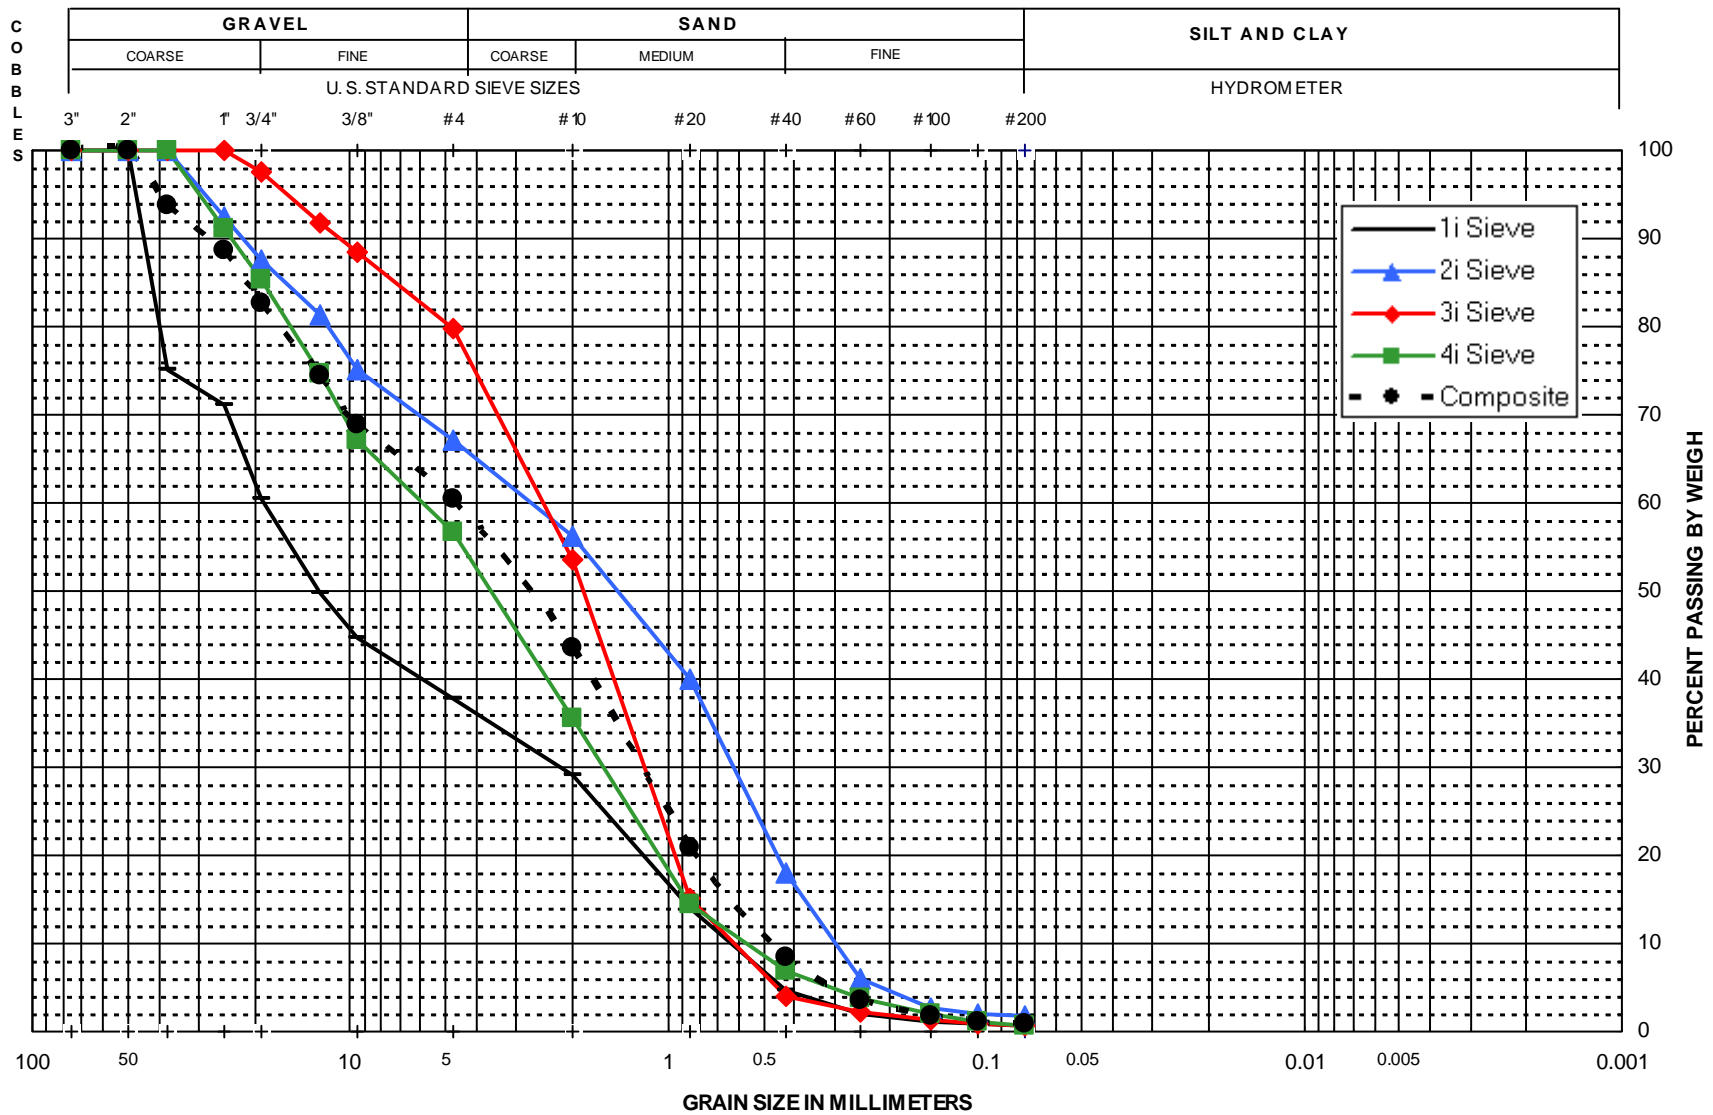
Figure 4-1 Invert Material Gradation Curve

Information on the sediment present in the system is required as part of the input to the sediment transport model. Bed (invert) and bank material was characterized at four locations in the SR-2 opportunity. The characterization locations included 300 ft upstream of the rock outcrop that forms the upper limit of the project reach (Sites 1i & 1b), 100 ft upstream of the sewer line crossing (Sites 2i & 2b), 150 ft upstream of the failing concrete wall grade control structure (Sites 3i & 3b), and 40 ft upstream of the stone grade control structure (Sites 4i & 4b). The "i" in the site name indicates it reflects the invert while the "b" reflects the bank. Soil gradation curves are shown on Figure 4.1 for the bed material and Figure 4.2 for the bank material at the four sites.

The sediment curves for the bed and bank at each site are similar throughout the study reach. Some variability can be expected even at the same location indicating that the sediment is similar throughout the project site with little variation from the upstream to the downstream limit of the project. A composite curve of all sites is shown on the sediment curve graphs and is considered to be representative of the sediment transported through the project reach. This composite curve was used in the sediment analysis.

The material contained in the channel bed includes a fairly even distribution of sands (coarse, medium, and fine) and fine gravels. While the bank material will contribute to the process, the material found in the bed dominates the sediment transport capacity. The bank material includes sand (medium and fine) as well as silts and clays. The bank material is dominated by the fine sands. However, the clay portion provides some measure of stability to the bank.
